SEAVIEW SQUARE MALL
SUMMARY OF AIR SAMPLING

Fred C. Hart Associates, Inc.
530 Fifth Avenue
New York, NY 10036

Equitable Real Estate Management Co., Inc.
101 Park Avenue
New York, NY 10178

MAY 1986

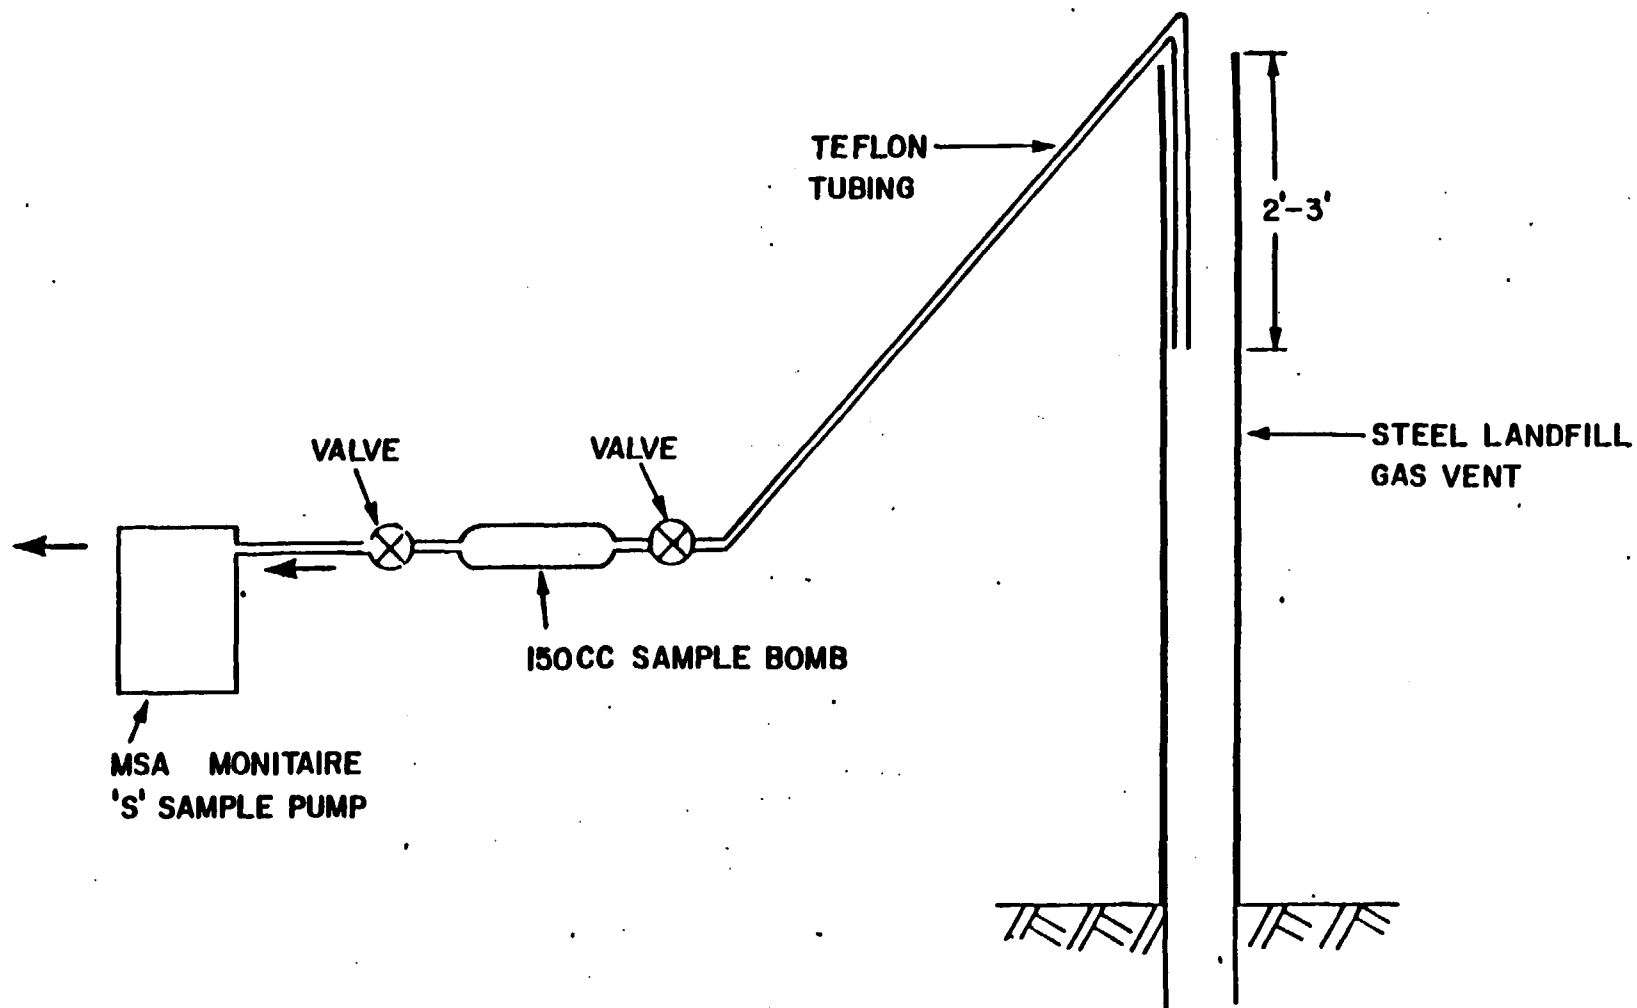
FIGURE 2
SCHEMATIC OF SAMPLING
TRAIN FOR SEAVIEW SQUARE
VENT SAMPLING PROGRAM

Samples were collected by climbing an eight-foot ladder, taping the sampling pump and cylinder to the top rung to the ladder, removing the vent cap, and snaking 1/4-inch Teflon tubing attached to the stainless steel sampling cylinder three to four feet down inside the vent. The cylinder valves were opened and the pump run for the specified time. The valve closest to the pump was closed, the second valve was closed, and the pump was shut off. The cylinder was then removed from the sample train, labeled and stored in an insulated container at ambient temperature. The samples were brought to the lab at the end of the day. The sampling pump was calibrated at 2 ml/sec. The prevailing wind was westerly at 20-25 mph with gusts to 50 mph; weather was sunny; ambient temperature was 43°F.

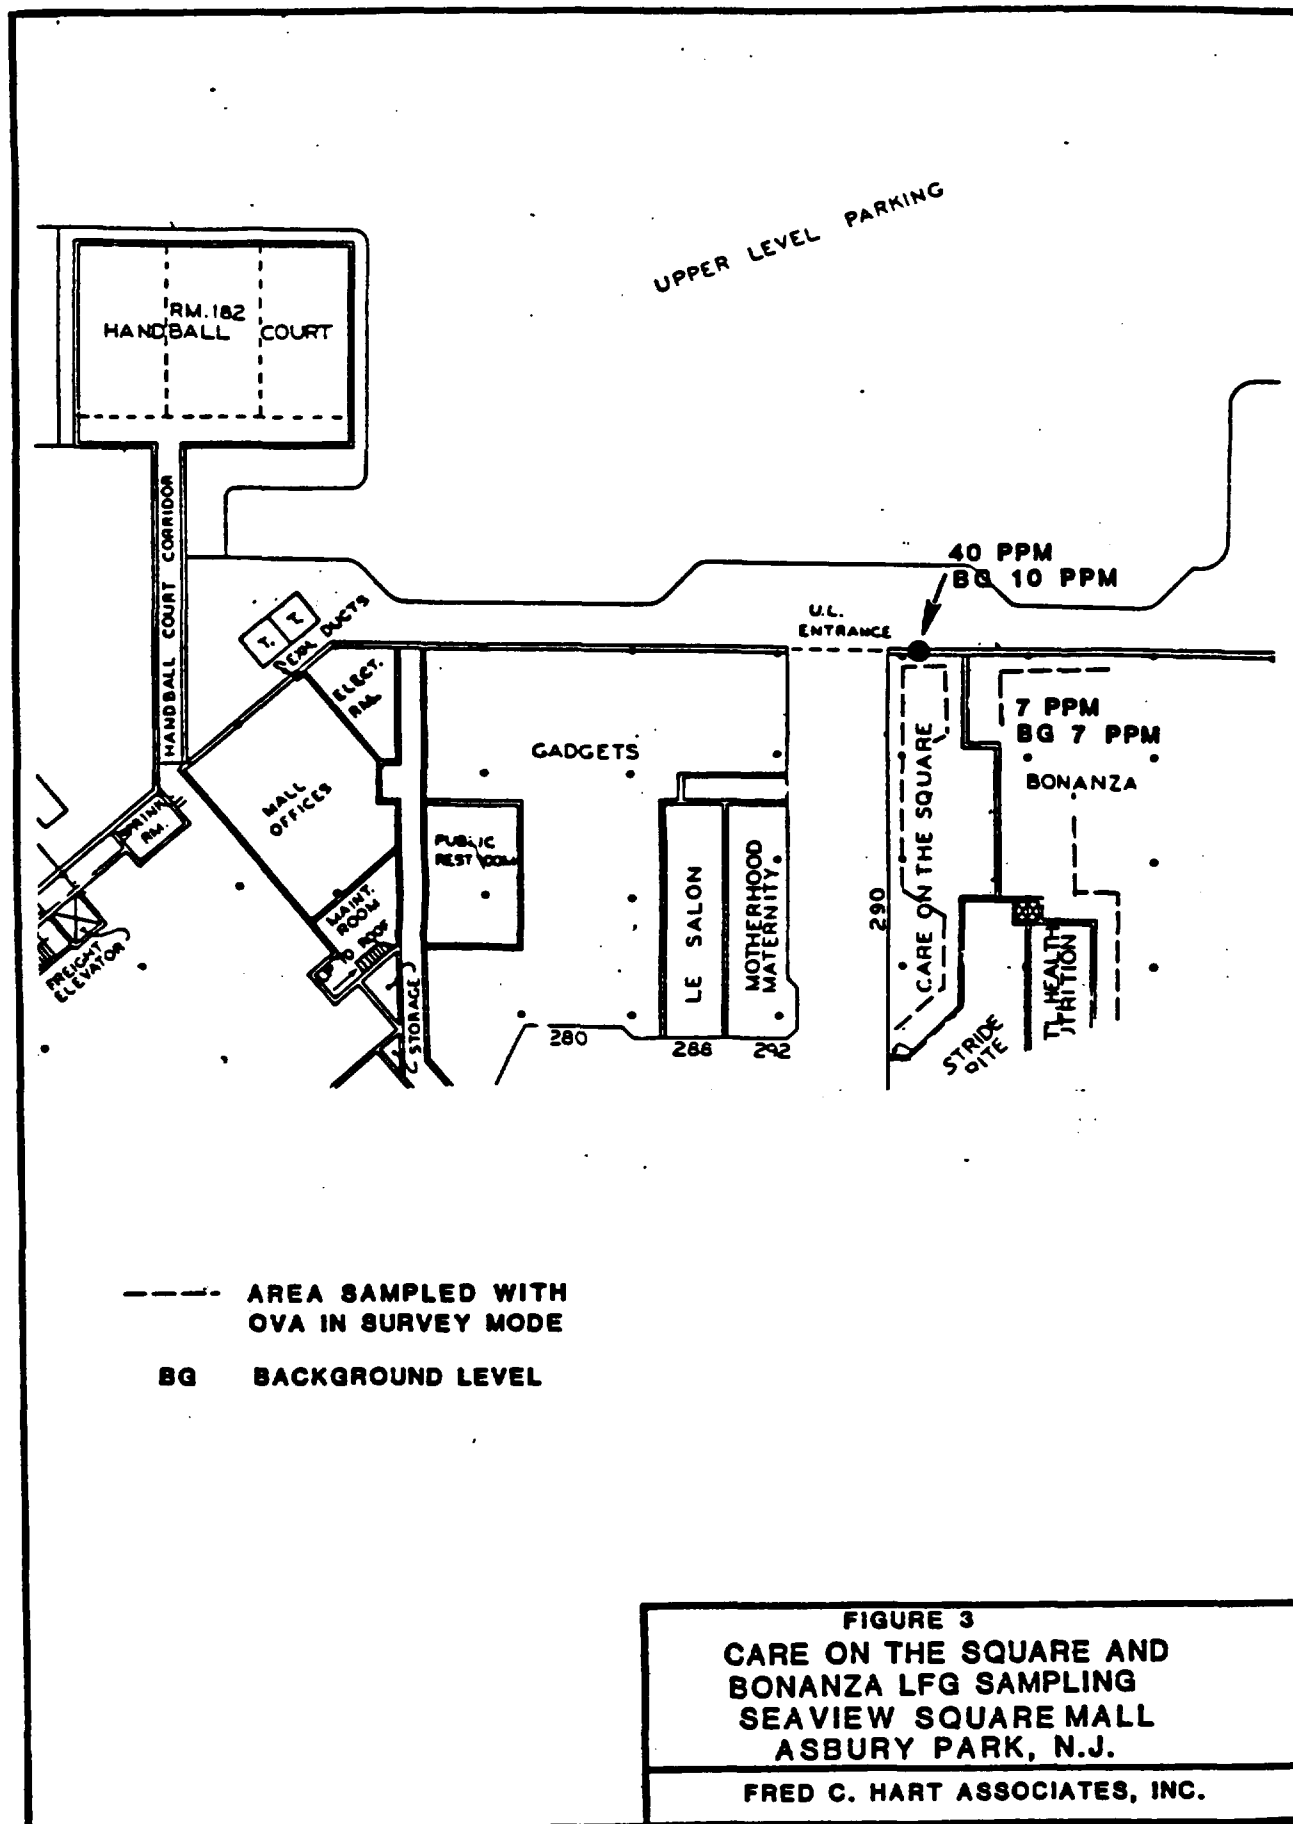
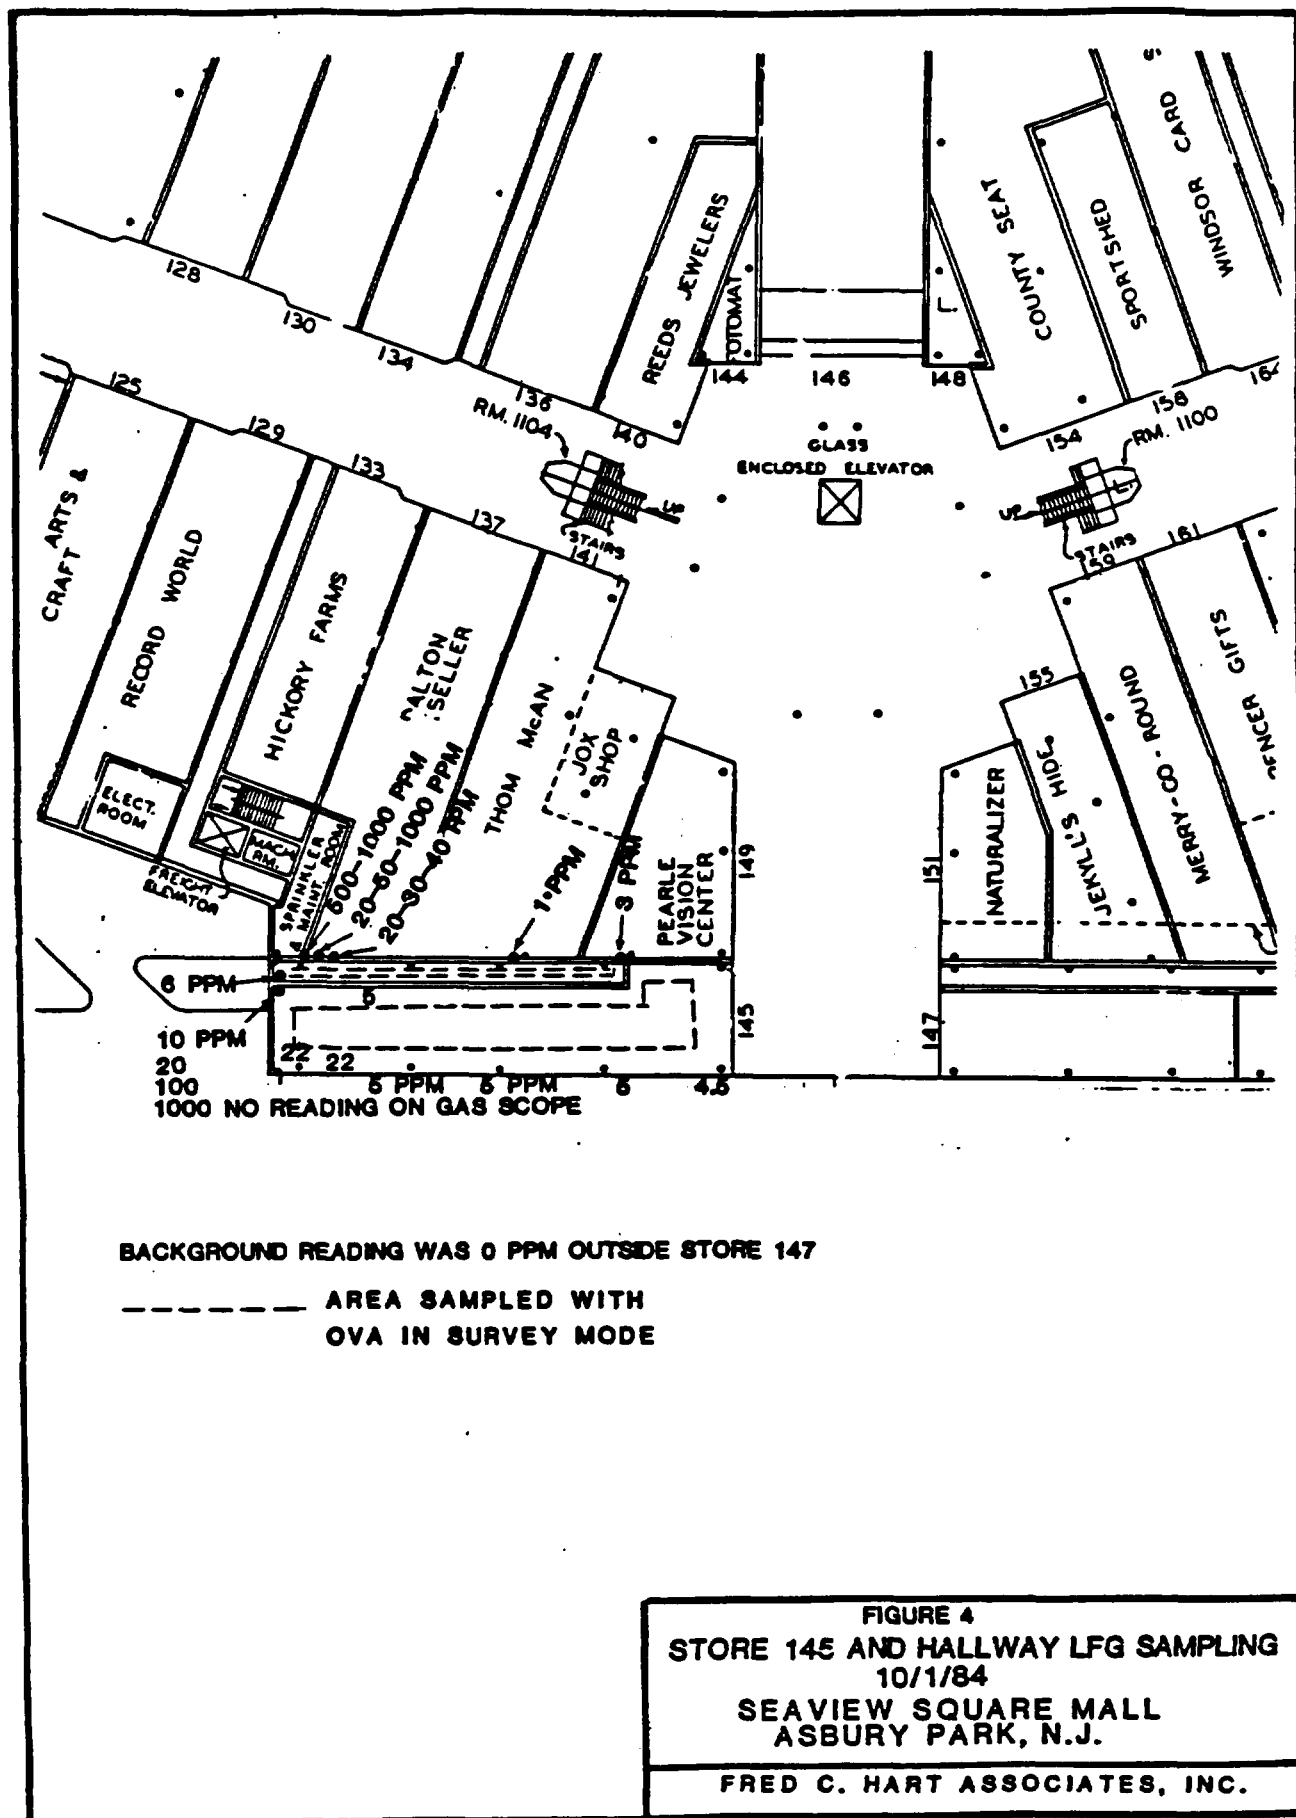
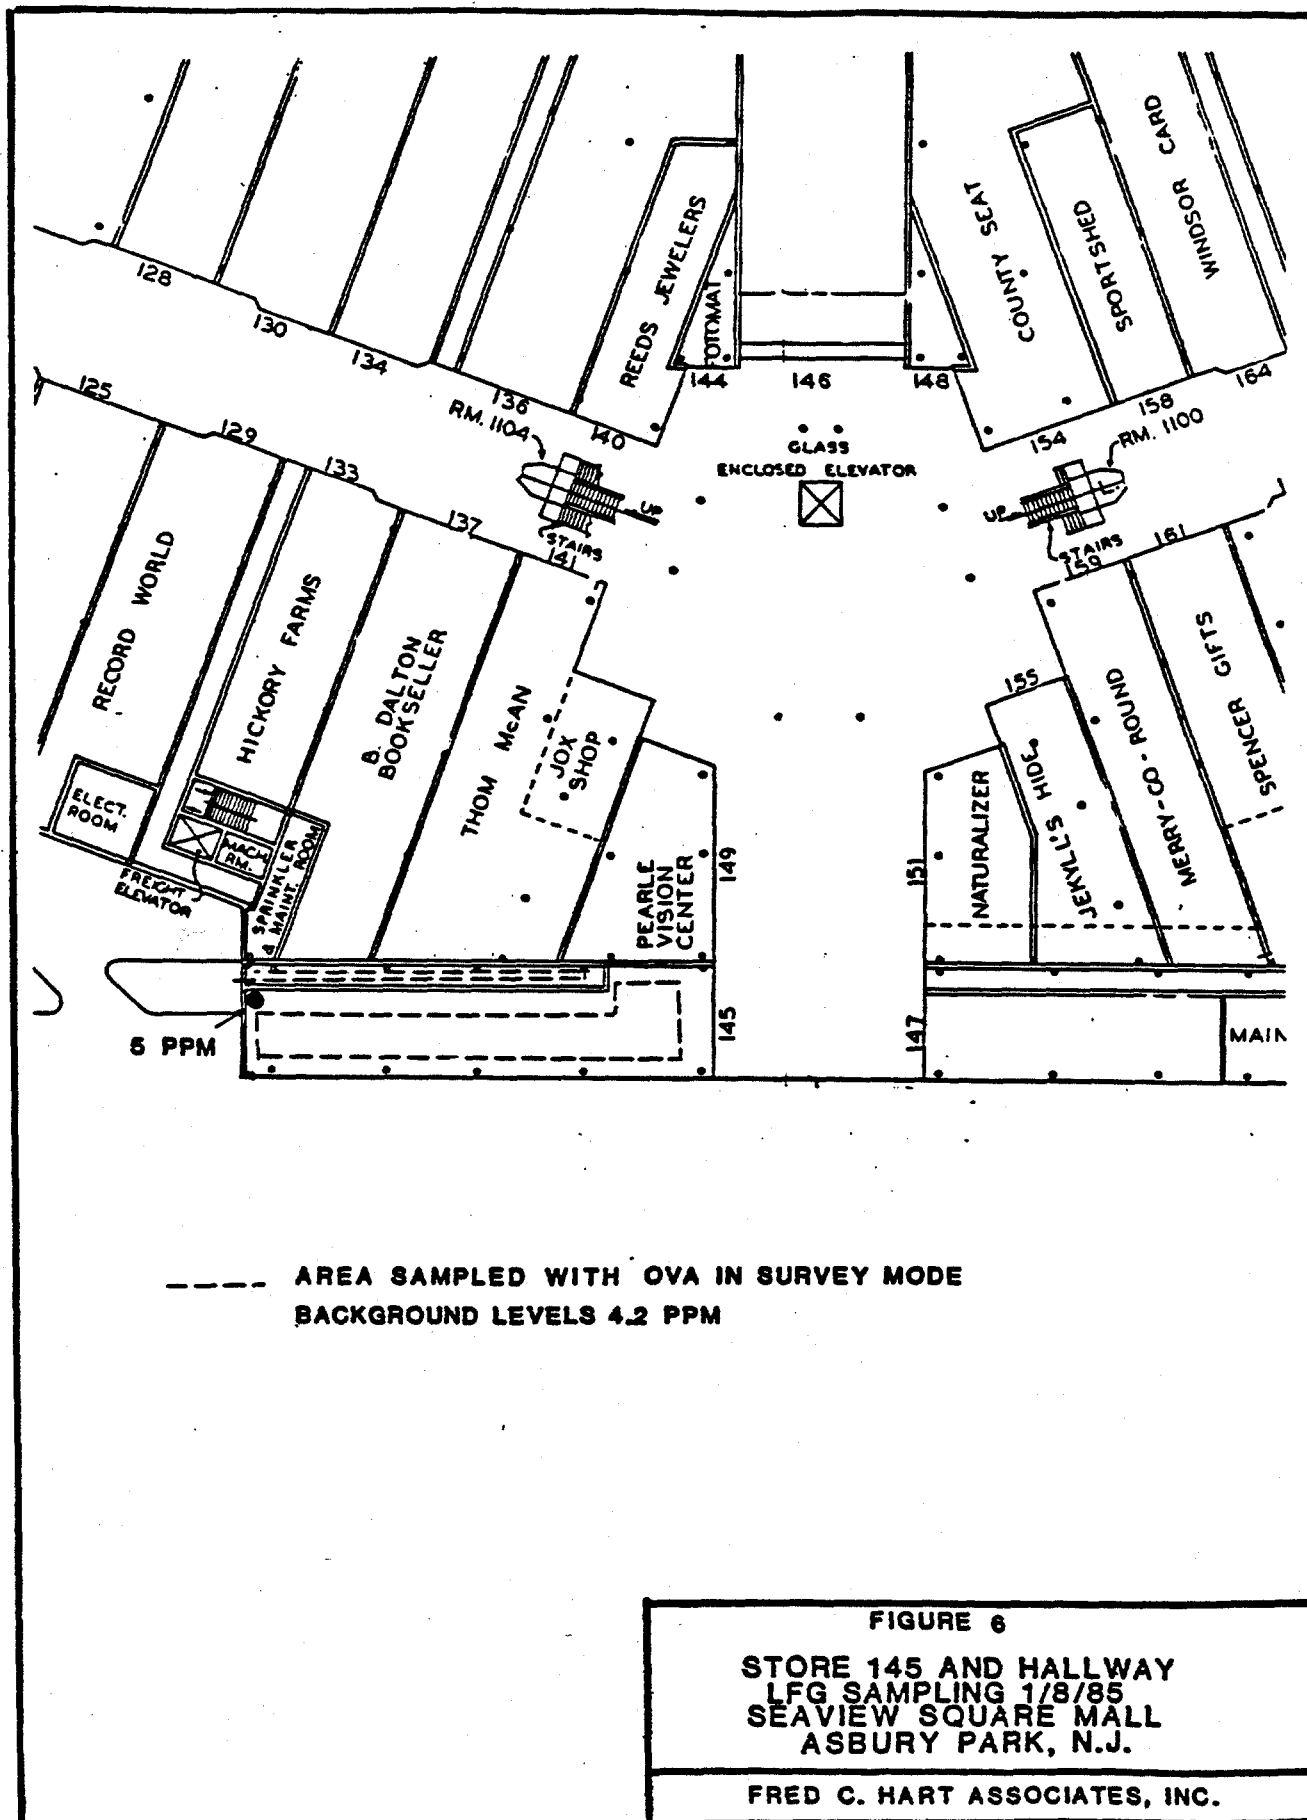
LFG levels were found to be at zero or ambient in all the areas surveyed except the hallway behind B. Daltons (300 ppm), room 145 (0 - 1000 ppm), the expansion joints in the hallway behind rooms 184-186-192 (0-850 ppm), near the Rite Aid delivery door (10 - 50 ppm), and Care on the Square (2.5 - 40 ppm). The data are summarized in Appendix A and shown in Figures 3, 4, 5 and 6.

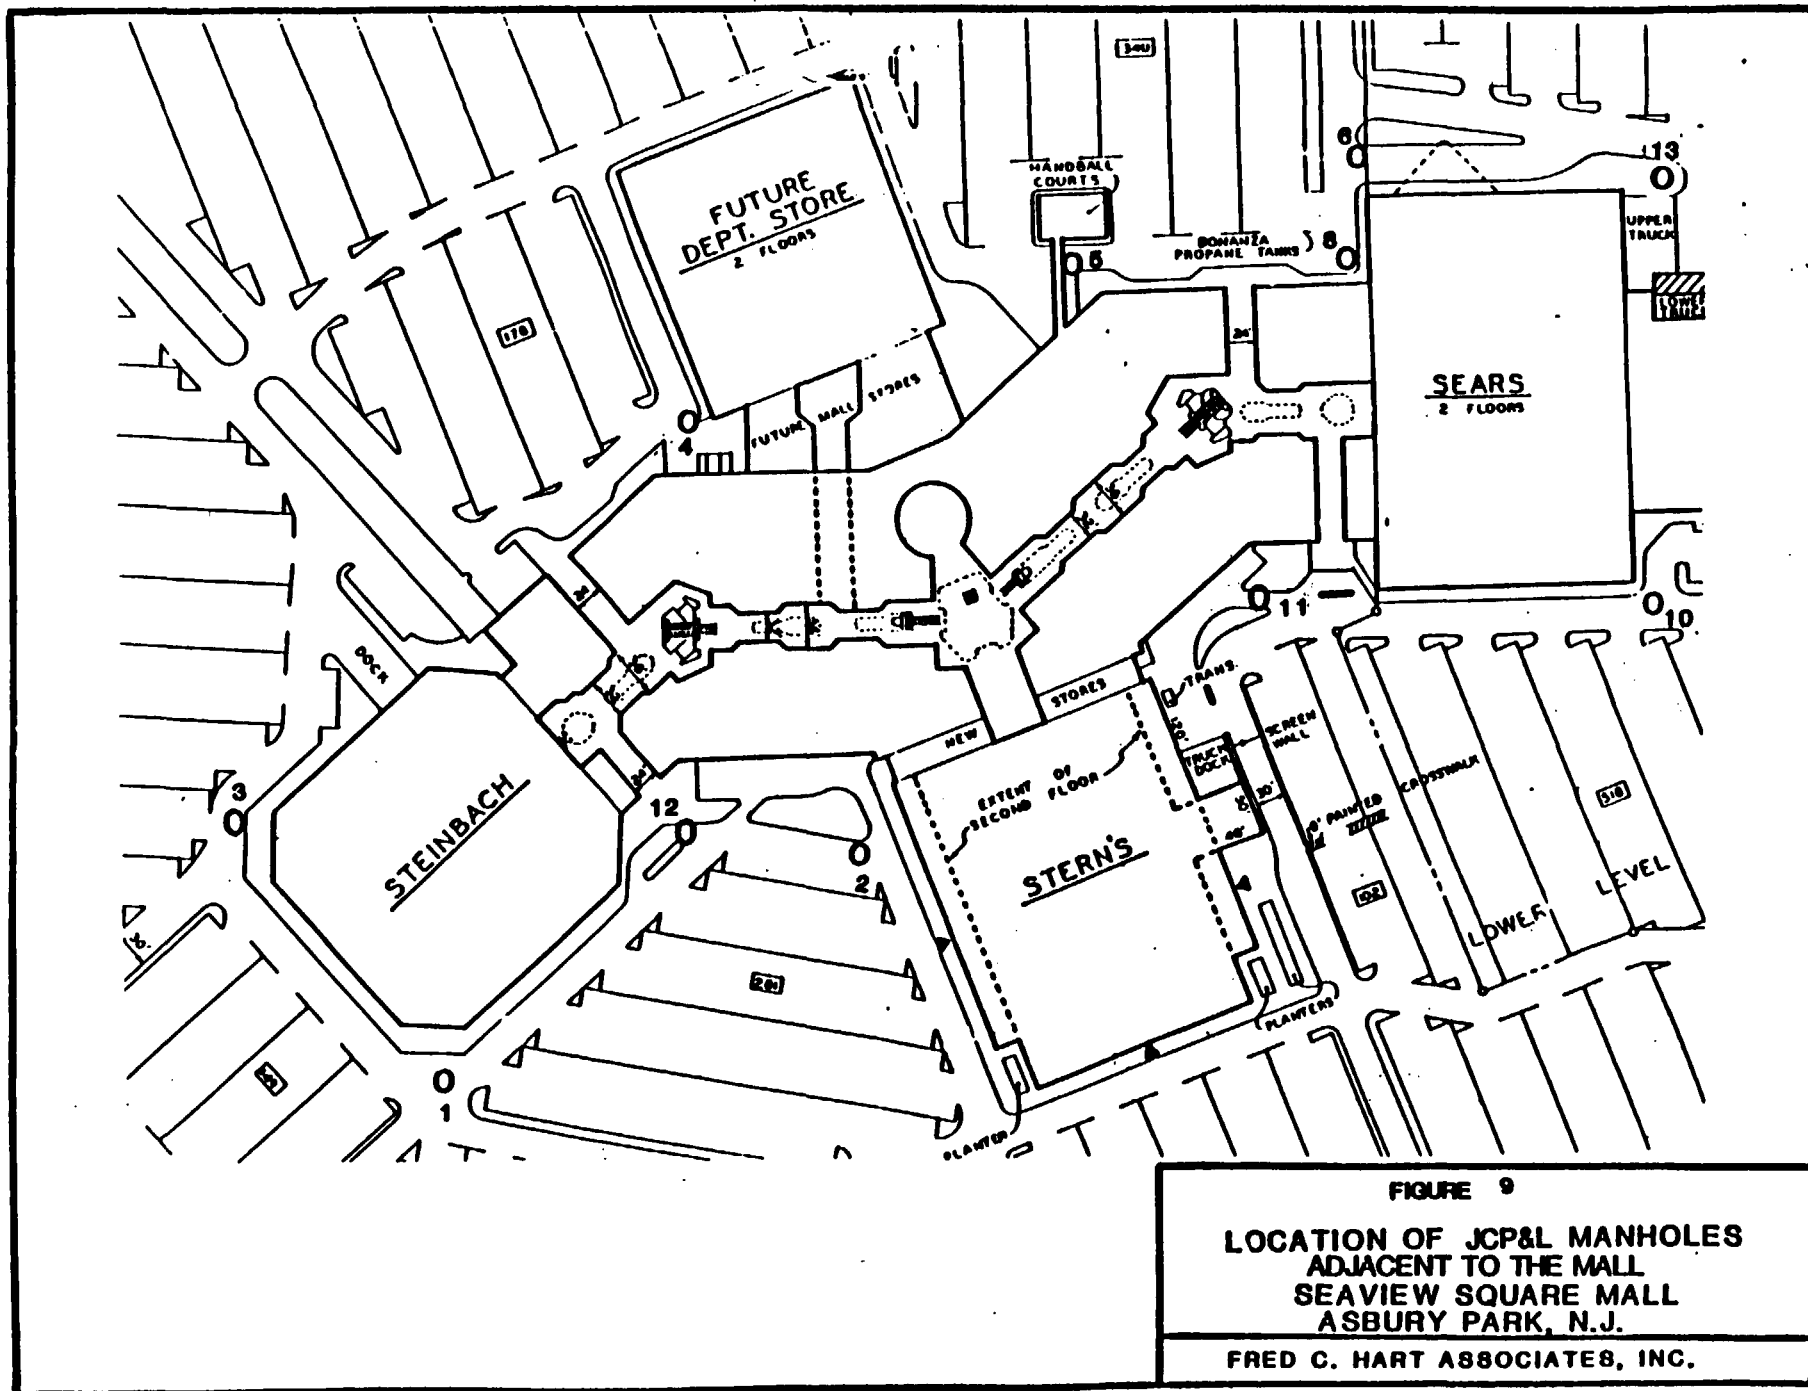
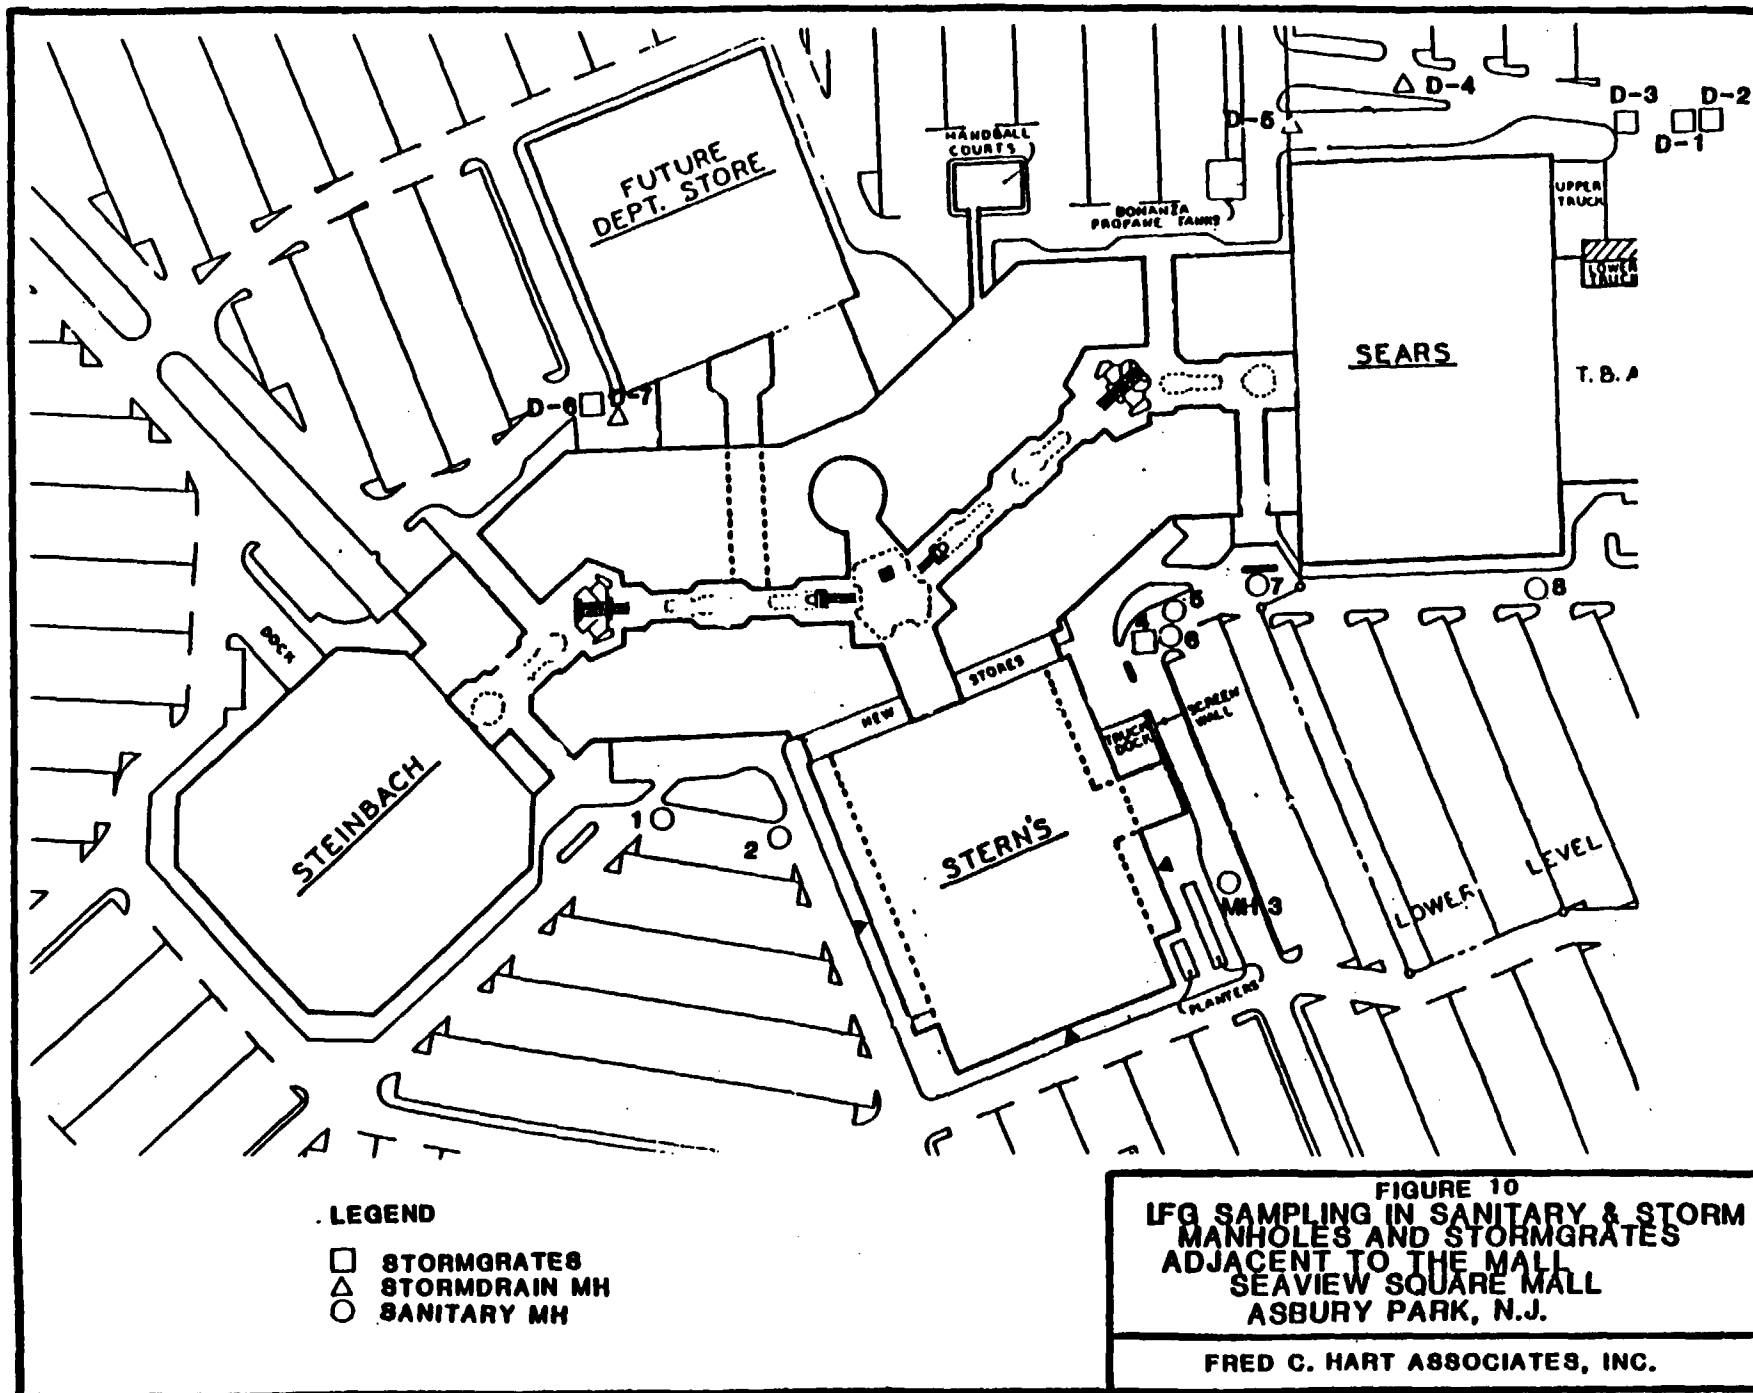
Sanitary manholes located adjacent to the mall were sampled in November 1984 for the presence of LFG. All sanitary manholes located throughout the mall property were sampled in January 1985. Readings ranged from background to 110 ppm adjacent to the mall and from 35 to over 1000 ppm in the manholes located on Ring Road and in the parking lot (Refer to Appendices C and D).
